# Summary Report on Building Performance

2004 Hurricane Season

FEMA 490 / March 2005

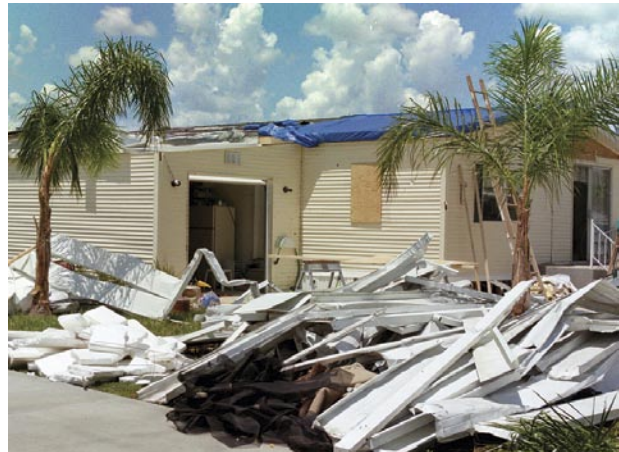
- **Manufactured housing.** Manufactured housing performance was a function of unit age and of the regulations under which they were constructed and installed. In high wind areas, pre-HUD standard homes were mostly destroyed beyond repair. Pre-1994 HUD standard homes performed variably, but the vast majority of these homes located in the path of Charley were damaged significantly even though the wind was less than the current design wind speeds. While post-1994 HUD standard homes performed well structurally, these units sustained damages related to building envelope and accessory structure failures. Improved performance of post-1994 manufactured housing was observed, however the MAT also found widespread damage caused by the failures of improperly designed and constructed attached accessory structures, such as carports and screen rooms. When these attached structures failed, they often tore away siding, roof covering, roof decking, and the exterior walls of the units to which they were connected.

Manufactured housing that had structural damage resulting from accessory structure failure.

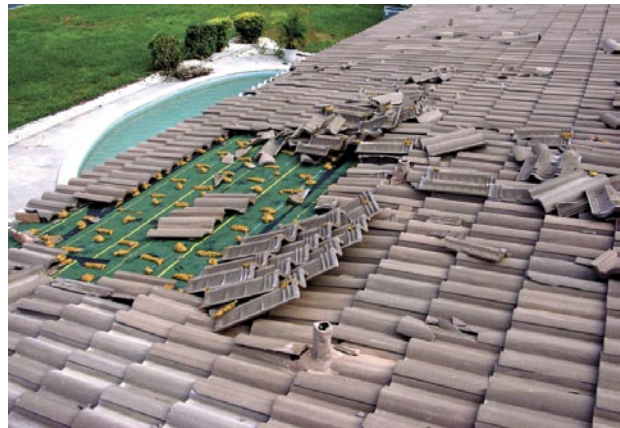
**Tiles.** Tile roof damage (both clay and concrete) occurred during Charley, Ivan, and Frances, but was most prevalent along the path of Hurricane Charley due in part to the large percentage of homes and buildings with tile roof coverings in Charlotte, Lee, and De Soto Counties. Tile damage from Hurricanes Frances and Ivan was also observed, both of which had much lower recorded wind speeds than Charley. Damage ranged from blow-off of hip and ridge tiles (which was very common even in areas with only moderate wind speeds) to large areas of blown off tiles (which was less common). The tile underlayments generally remained intact so even buildings with significant blow-off areas typically experienced little or no water infiltration from the roof (except in cases where the roof deck failed). Tiles located on ridges, hips, and edges of the roof were frequently a point of failure, especially when they lacked mechanical anchors.

In addition to the damage shown in this photo, this one-story roof lost virtually all of the hip and ridge tiles during Hurricane Charley. (Punta Gorda Isles)

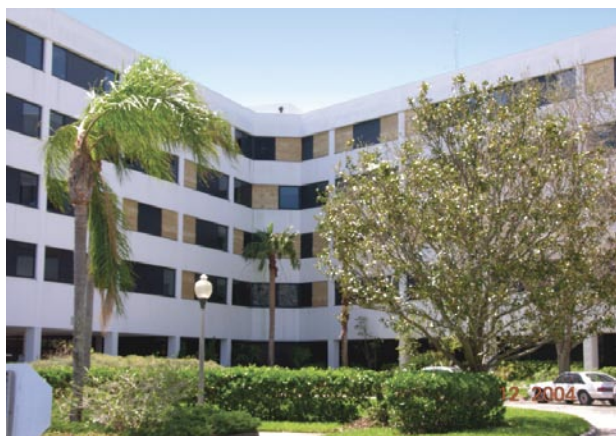
Aggregate from the Indian River Memorial Hospital's roof (Vero Beach) broke several of the patient room windows (which were covered with plywood after Hurricane Frances).

Staff removed loose aggregate from the built-up roofs just prior to Frances' landfall, likely minimizing window breakage and thereby preserving the availability of patient rooms. Additionally, the aggregate surface of a portion of the upper roof had been previously re-roofed in a manner that encapsulated the aggregate, preventing aggregate blow-off.

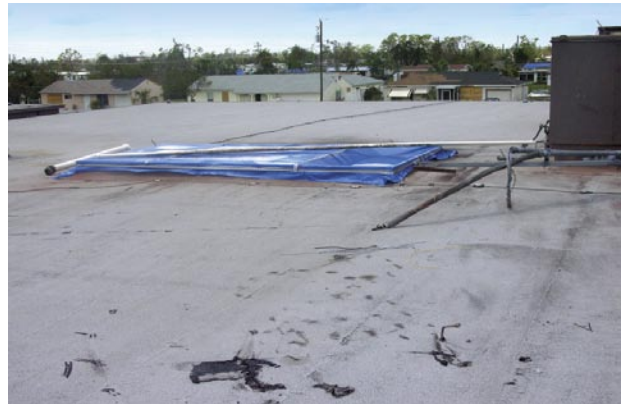
A large HVAC package unit was blown off this curb during Hurricane Charley. Note the loose LPS conductors this side of the curb. This school had significant damage from several pieces of rooftop equipment that blew off the building roof. (Port Charlotte Middle School)

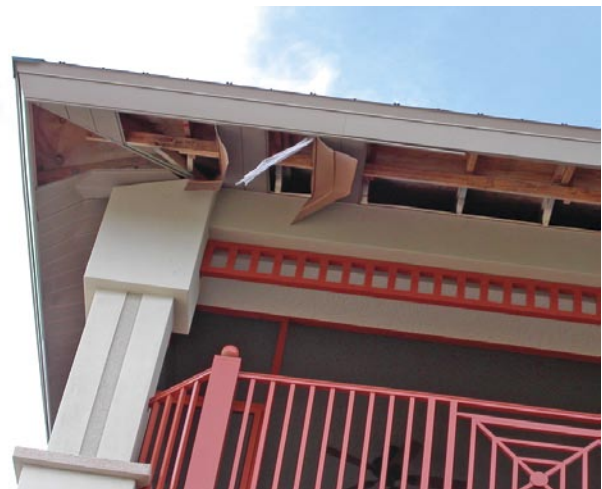
Soffit damage on the third story of a multi-family building. (Captiva Island)

Soffit failure led to many instances of significant damage to building interiors.

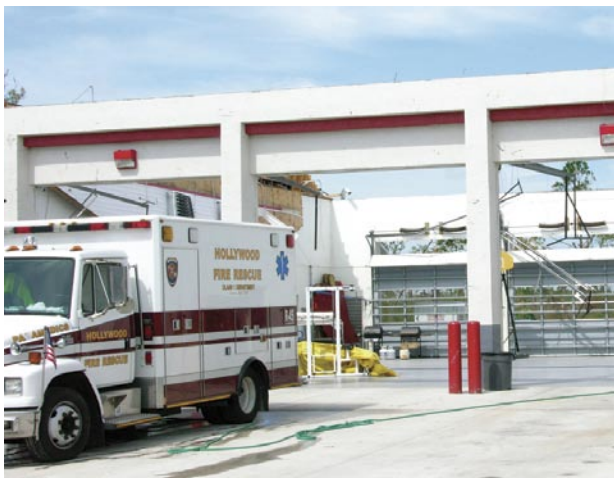
Failure of three of six new doors on a fire station in Charlotte County resulted in the loss of the entire roof structure over the apparatus bay during Hurricane Charley.

more common. Failure of an exterior door has two important effects. First, failure can cause an increase in internal pressure, which may lead to exterior wall, roof, interior partition, ceiling or structural damage. Second, wind can drive rain water through the opening, damaging interior contents and leading to mold development. Interior building damage resulting from door failures is generally preventable if doors and tracks that connect roll up doors to walls are strengthened and reinforced.

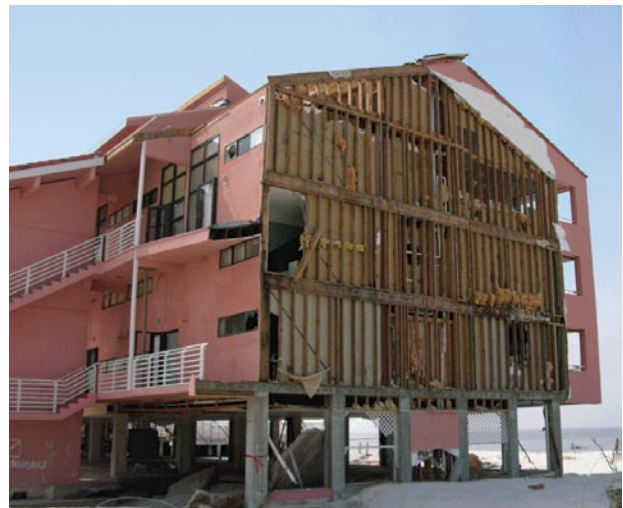
Example of wall cladding failure. The building had synthetic stucco installed over molded, expanded polystyrene insulation and gypsum board. The gypsum board blew off during Hurricane Ivan.

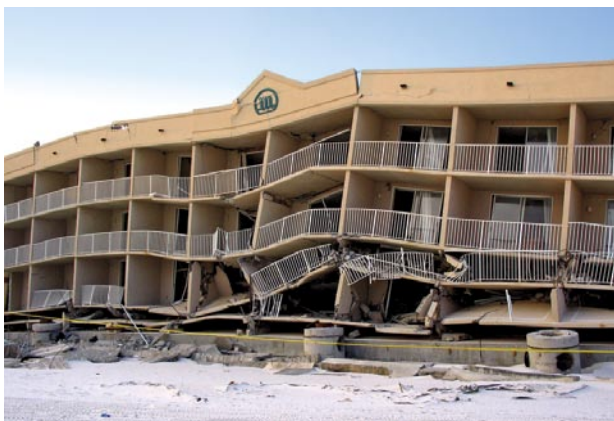
cases were building failures due to erosion of supporting soil under buildings with shallow foundations.

A multi-family condominium collapsed after Hurricane Ivan due to erosion of supporting soil under the shallow foundation.

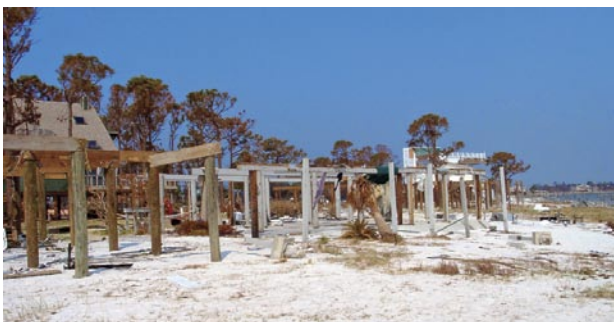
Several structures were completely torn off their pile foundations during Hurricane Ivan as a result of significant flood depths, waterborne debris impacts, and lack of connections.

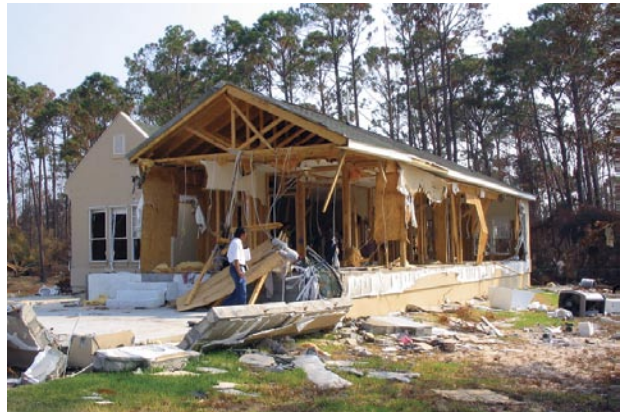
Flood water from Hurricane Ivan exceeded the required elevation of the top of the lowest floor supported by the stem wall foundation for this house leading to severe damage caused by waves and debris impact.

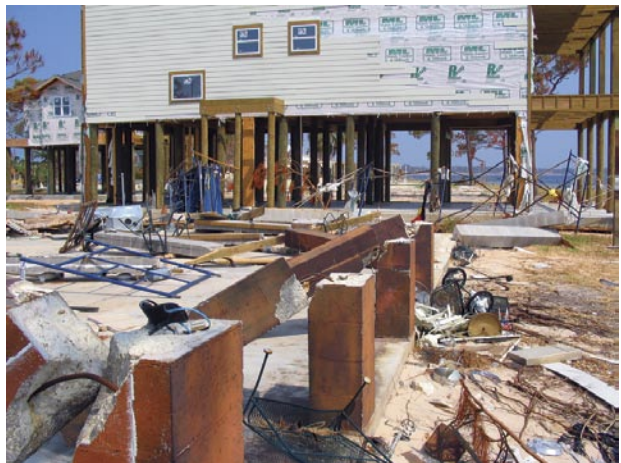
High flood levels during Hurricane Ivan and lack of structural capacity to withstand waves and debris loads caused this reinforced pier foundation to fail.

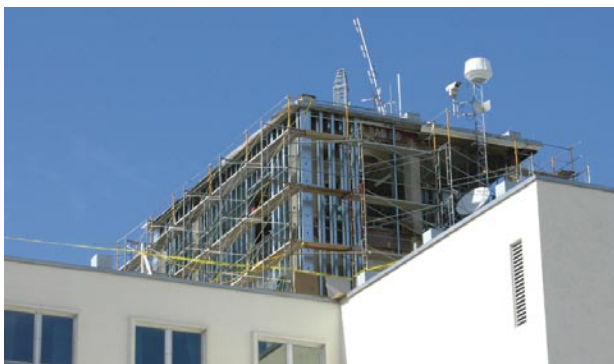
At the Martin Memorial Hospital (Stuart, Florida) wall panels blew off the elevator penthouse during Hurricane Frances. Rain water entered the elevator equipment room damaging much of the equipment. The falling panels punctured the main roof and at least one of the lower roofs. Because of rain water infiltration and lack of elevator service, floors 2 through 6, which contained 75% of the hospital's beds, were inoperative. Many patients were relocated to other hospitals until the penthouse walls were re-sheathed and new elevator equipment was installed.

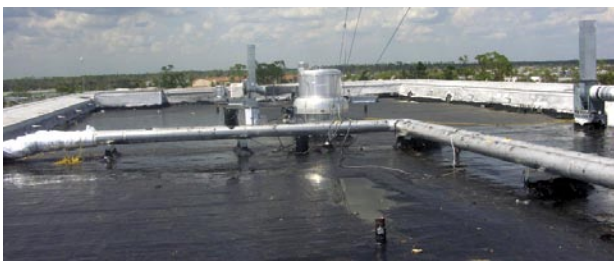
An emergency roof (shown) was installed after Hurricane Charley blew the mechanically attached PVC membrane roof covering off the concrete deck of the Fawcett Memorial Hospital.

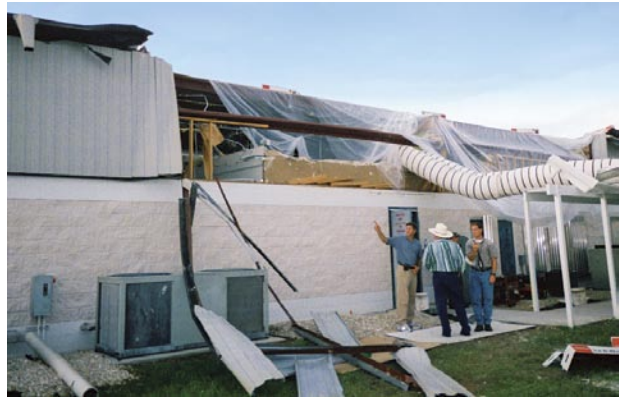
The Charlotte County Sheriff's Office/County EOC, located in a pre-engineered metal building, was significantly damaged and completely taken offline. Despite having openings protected with shutters, the building failed by loss of roof panels (failure of roof clips) and loss of metal wall panels. These failures allowed damaging amounts of rain and debris to enter the facility resulting in closure of the building. The county was aware of the weakness of this facility, and prior to Charley, had begun the design process for a new county EOC facility that would meet statewide Enhanced Hurricane Protection Areas (EHPA) requirements and guidelines not used in the design of the existing structure.

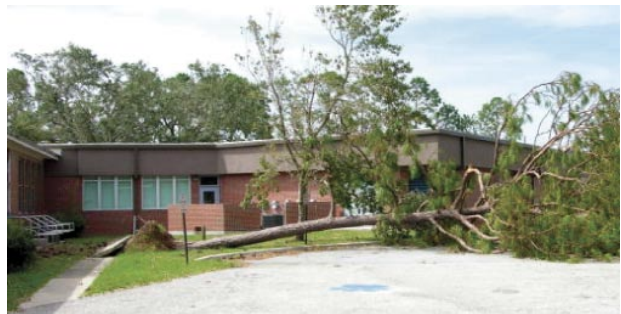
This school building experienced several building envelope problems, which allowed water intrusion, but it did not disrupt operations. Damage and disruptions may have been worse if design wind speed conditions had been experienced.
